**ASSESSMENT OF FLOODING ISSUES AND POSSIBLE
MITIGATION STRATEGIES FOR THE CITY OF
FREDONIA, IOWA**

by
Daniel Gilles and Nathan Young

Submitted to
The City of Fredonia
Louisa County Emergency Management

July 2019

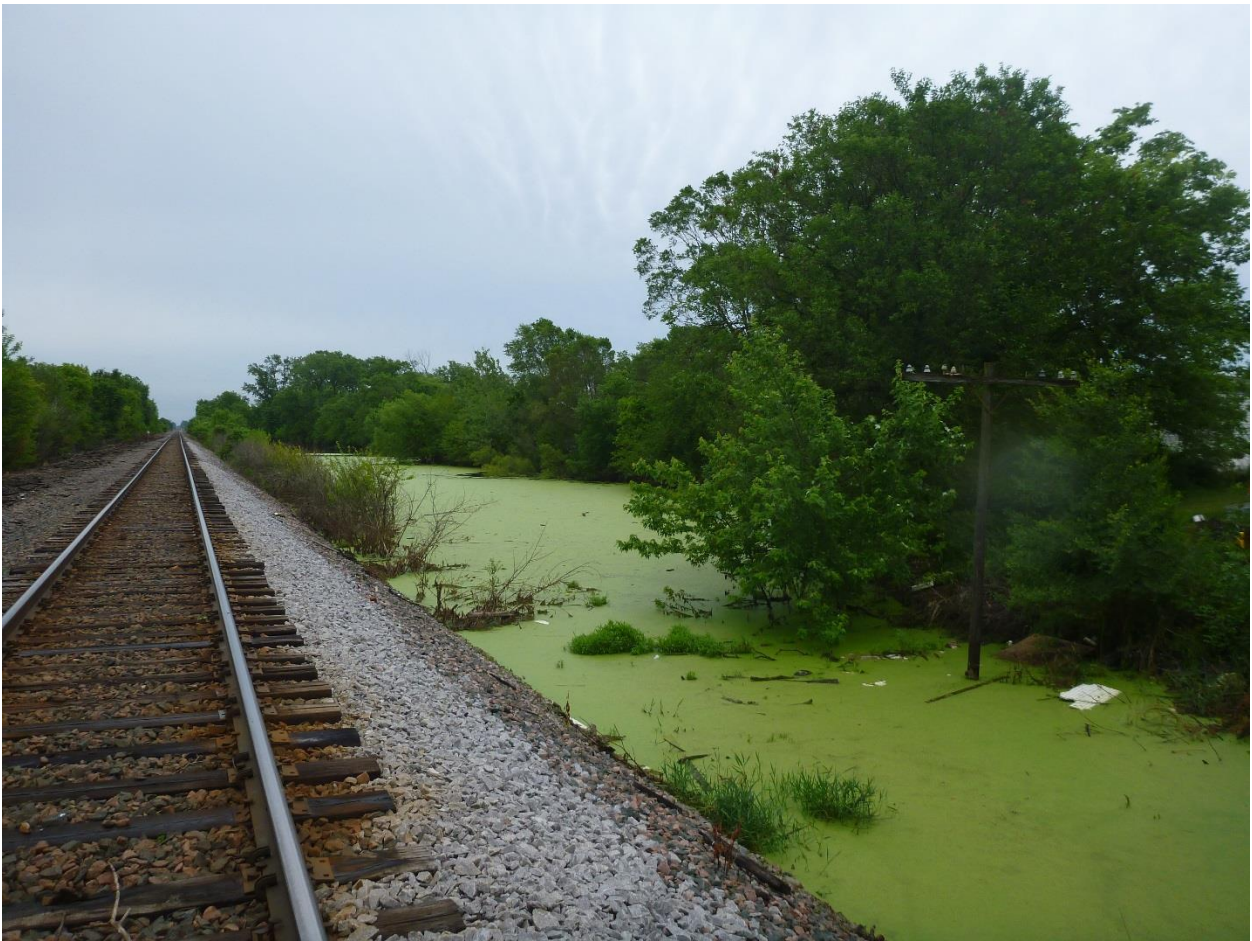
An agricultural catchment, shown in Figure 2.5, contributes runoff that drains into a pond just northeast of the city of Fredonia, shown in Figure 2.6. The pond is located along the Iowa, Chicago and Eastern Railroad. A photograph of the southern portion of the pond is shown in Figure 2.7. The approximate drainage area entering the pond is 750 acres (1.2 square miles). At low flow, the southern portion of the pond discharges via an 18-inch corrugated plastic pipe (R. Bright, Fredonia resident, personal communication, 6/21/2019), eventually reaching the Cedar River. Following heavy rainfall, the pond's low flow outlet can become overwhelmed, once pond storage is exhausted, flood water begins flowing into the city of Fredonia.

Figure 2.7. The southern portion of the pond along the IC&E railroad embankment, view is looking northeast.

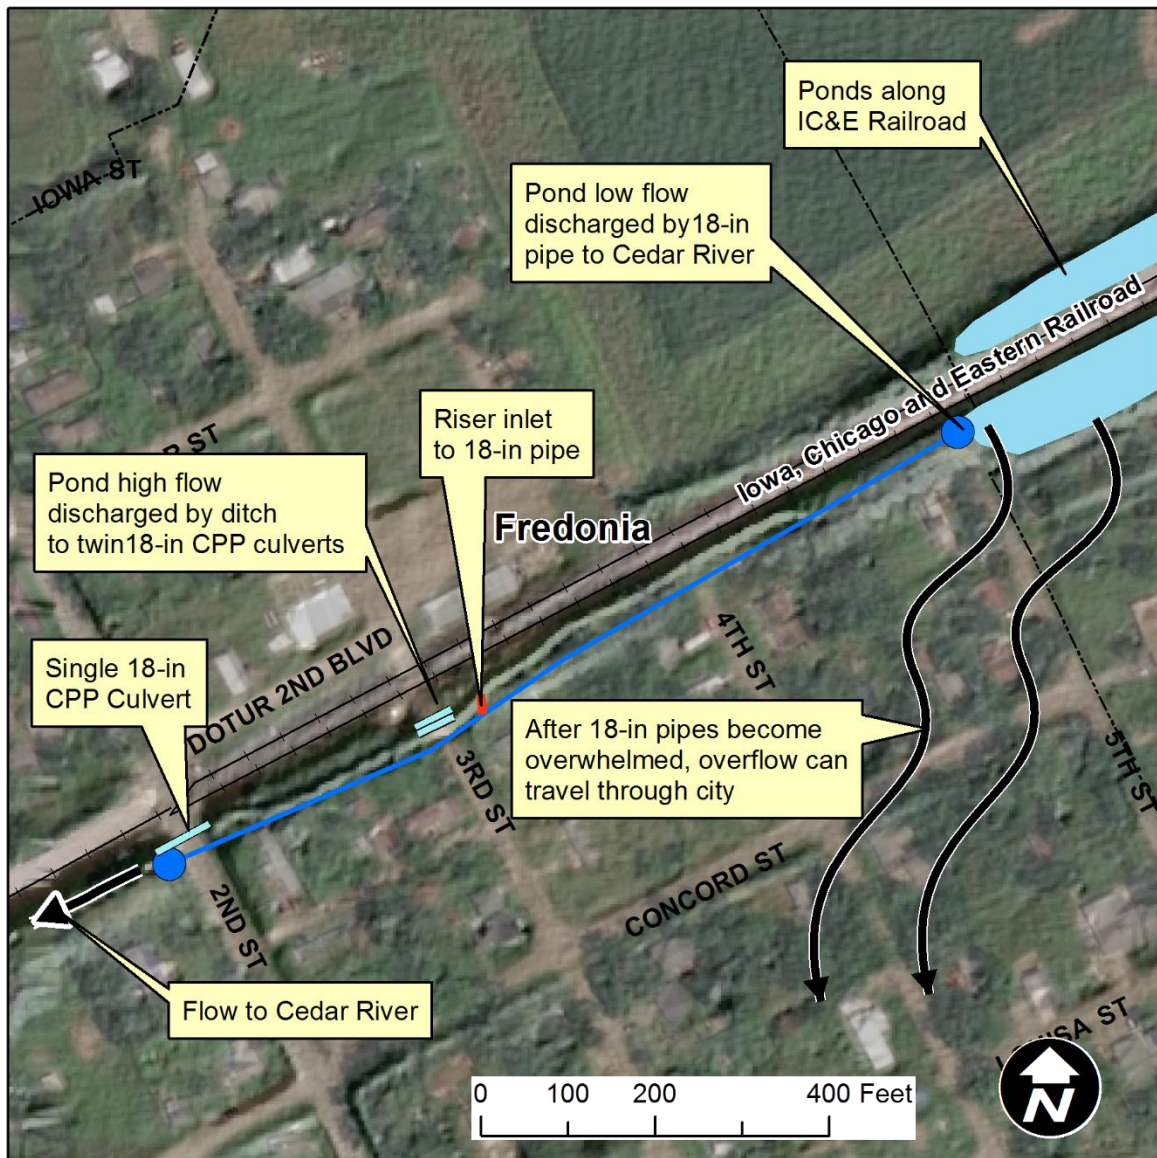
Figure 2.8 shows a close-up view of the approximate location of pipes, culverts, and ditches that convey pond discharge through the city of Fredonia, eventually reaching the Cedar River. Figure 2.9 and Figure 2.10 show street views along the drainage way, near the intersection of 3rd Street and the railroad.

Figure 2.8. Pipes and culverts that convey pond discharge to Cedar River. Locations are approximate.

This alternative replaces the existing 18-inch pipe used as the primary outlet with three 48-inch reinforced concrete pipes. The alignment of the outlet pipe would remain relatively unchanged, and follow the current outlet pipe corridor. The upstream inverts of the pond outlet pipes would be lowered approximately 2 feet to elevation 593 feet (NAVD88), from the estimated existing upstream pipe invert of approximately 595.0 feet (NAVD88)

This alternative replaces the existing 18-inch pipe used as the primary outlet with an open channel ditch. The ditch has a bottom width of 6 feet, a depth of 6 feet, 2:1 (H:V) side slopes, and a top width of 30 feet. The channel slope would be 0.003. The alignment of the ditch would remain relatively unchanged from the current outlet pipe corridor. The upstream invert of the open ditch would be lowered approximately 2 feet to an elevation of 593 feet (NAVD88), from the estimated existing upstream pipe invert of approximately 595.0 feet (NAVD88). The downstream invert would remain approximately unchanged, based on the estimated downstream invert elevation of 530 feet (NAVD88).

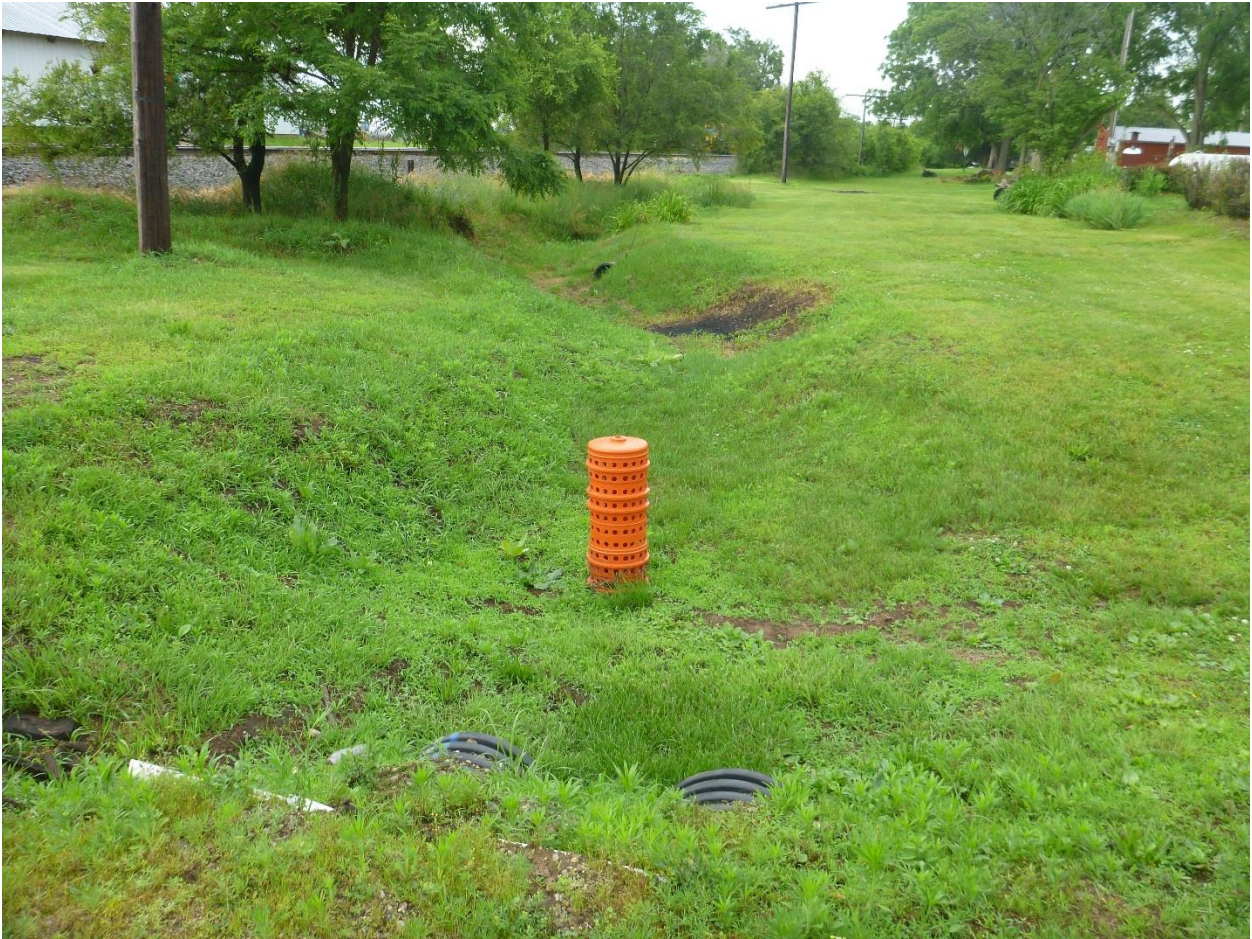
Figure 2.9. View near the intersection of 3rd Street and the railroad, looking northeast. Twin 18-in corrugated plastic culverts convey ditch flow under 3rd street. An orange riser is connected to the 18-in pipe that drains the pond.

- Seek grant opportunities to pursue a more detailed study to reduce flood risk through mitigation alternatives that could include providing a higher capacity pond outlet
- Perform maintenance on the pond outlet pipe, culverts, and drainage ditches to remove sediment, vegetation and debris
- Coordinate with Louisa County, any drainage districts, and Iowa, Chicago and Eastern Railroad to explore any opportunities to improve the current drainage situation
- Continue to coordinate with Louisa County Emergency Management and pursue any funding opportunities offered by FEMA and Iowa Department of Homeland Security

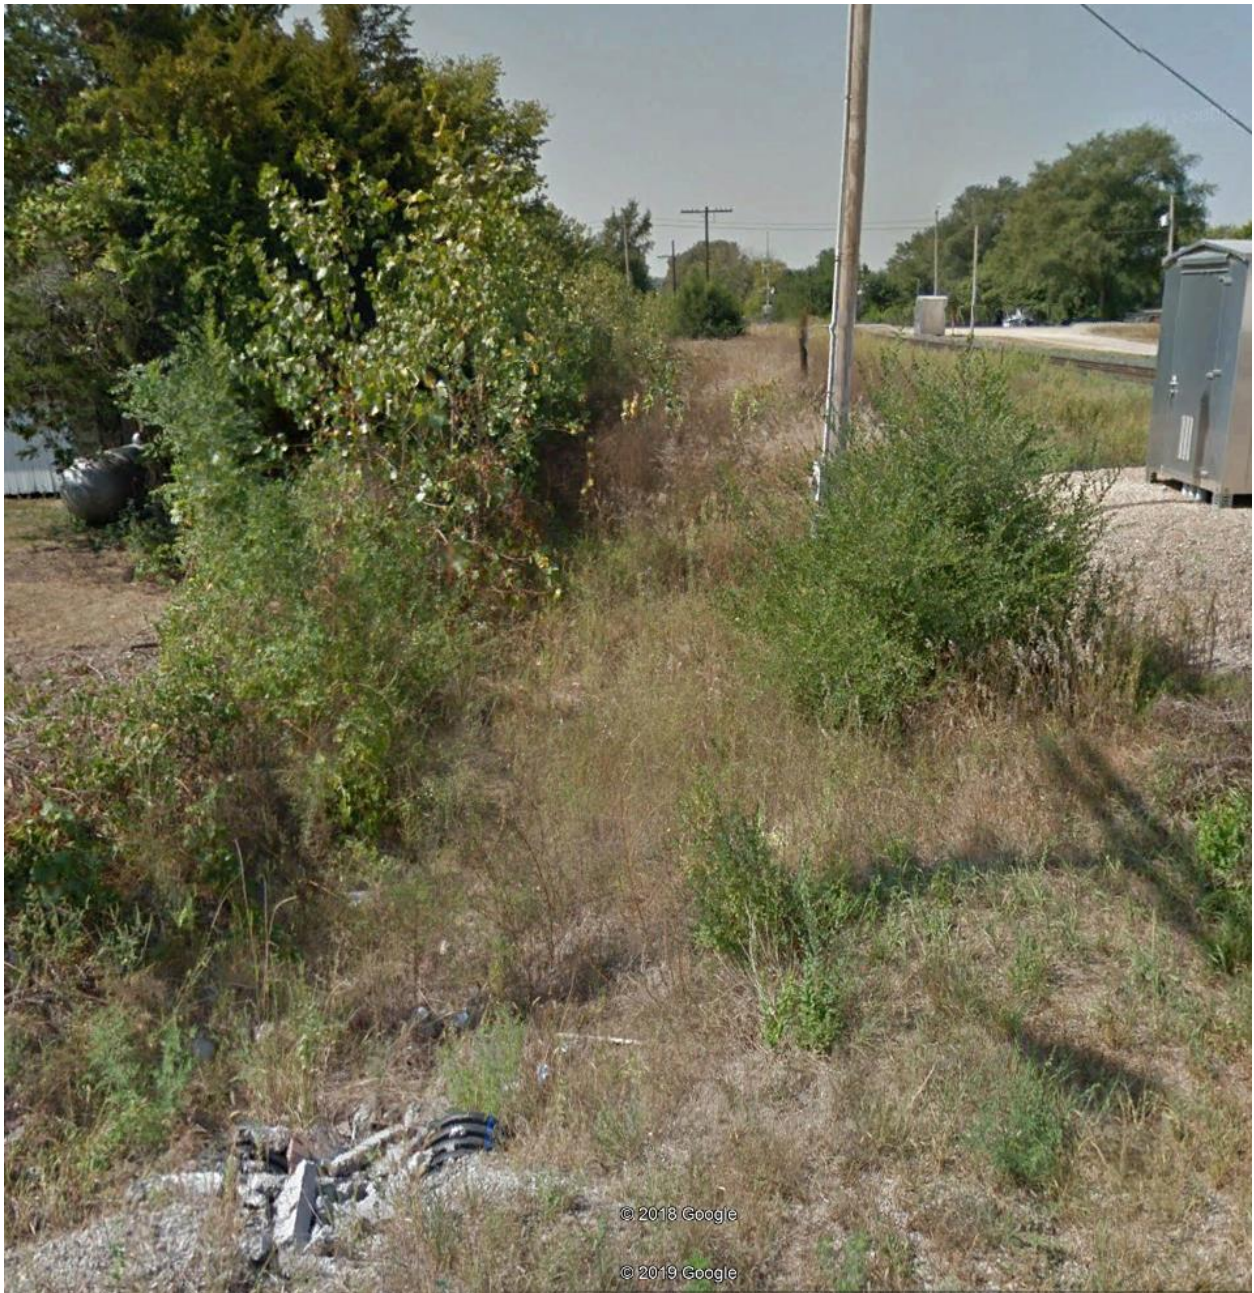
Figure 2.10. View near the intersection of 3rd Street and the railroad, looking southwest. Twin 18-in corrugated plastic culverts convey ditch flow under 3rd street.

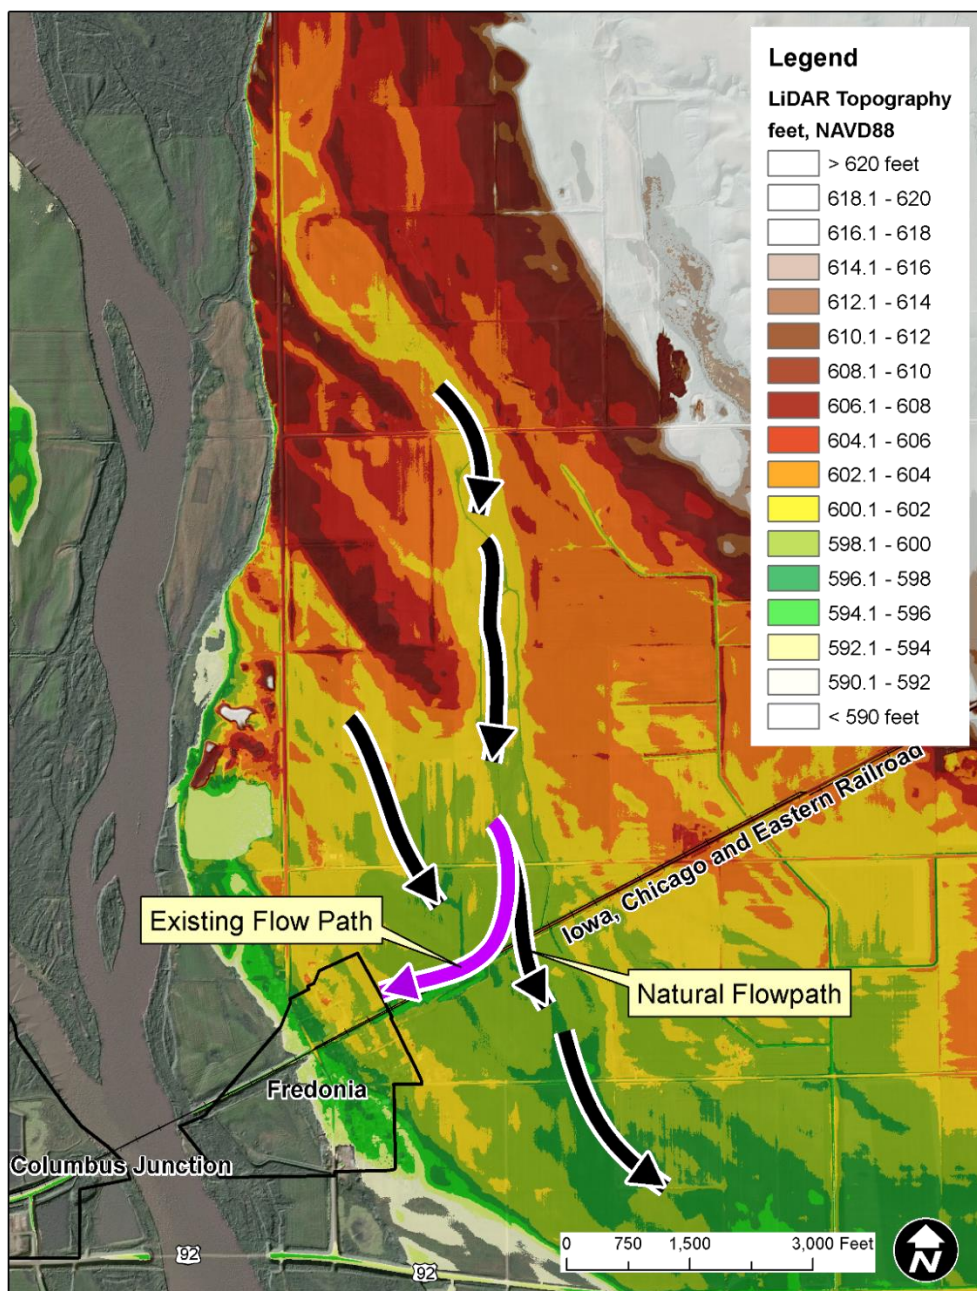
The natural flow path of this drainage area appears to have been to the southeast, following the gentle slope of the upland terrace. This is emphasized in **Figure 2.11** along with the LiDAR topography. The flow path was likely diverted when the railroad embankment was constructed.

Figure 2.11. LiDAR terrain indicates the original flow path for this drainage area was likely to the southeast, rather than the existing flow path, which flows along the railroad to the southwest.

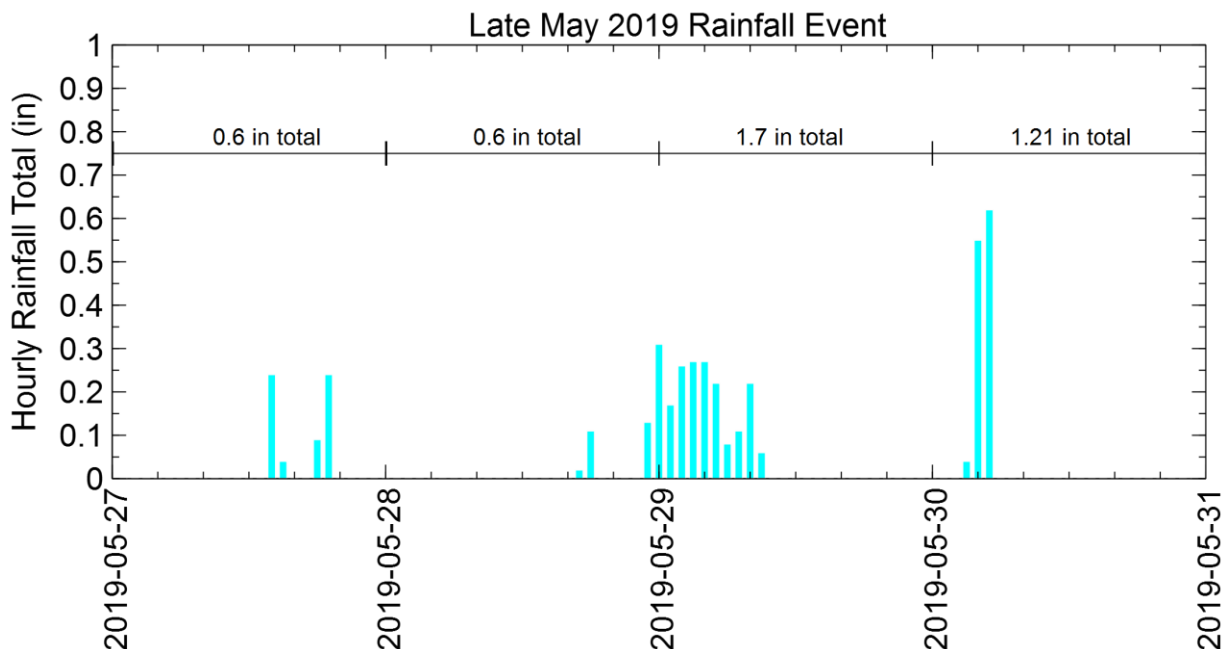
A series of rainfall events occurring from May 27 – 30, 2019, overwhelmed the nearby pond and culminated in flash flooding. Many homes experienced basement flooding. Figure 3.1 shows hourly rainfall amounts, along with daily rainfall totals estimated using Multi-Radar/Multi-Sensor System (MRMS) data produced by the National Air and Space Administration (NASA). By May 30th, soils had become nearly saturated and produced significant runoff.

Figure 3.1. Hourly rainfall totals near Fredonia prior to the May 30th 2019 flooding derived from radar rainfall estimates. Daily total rainfall amounts are shown above.
