**ASSESSMENT OF FLOODING ISSUES AND POSSIBLE
MITIGATION STRATEGIES FOR THE CITY OF
PLAINFIELD, IOWA**

by
Daniel Gilles

Submitted to
The City of Plainfield

July 2018

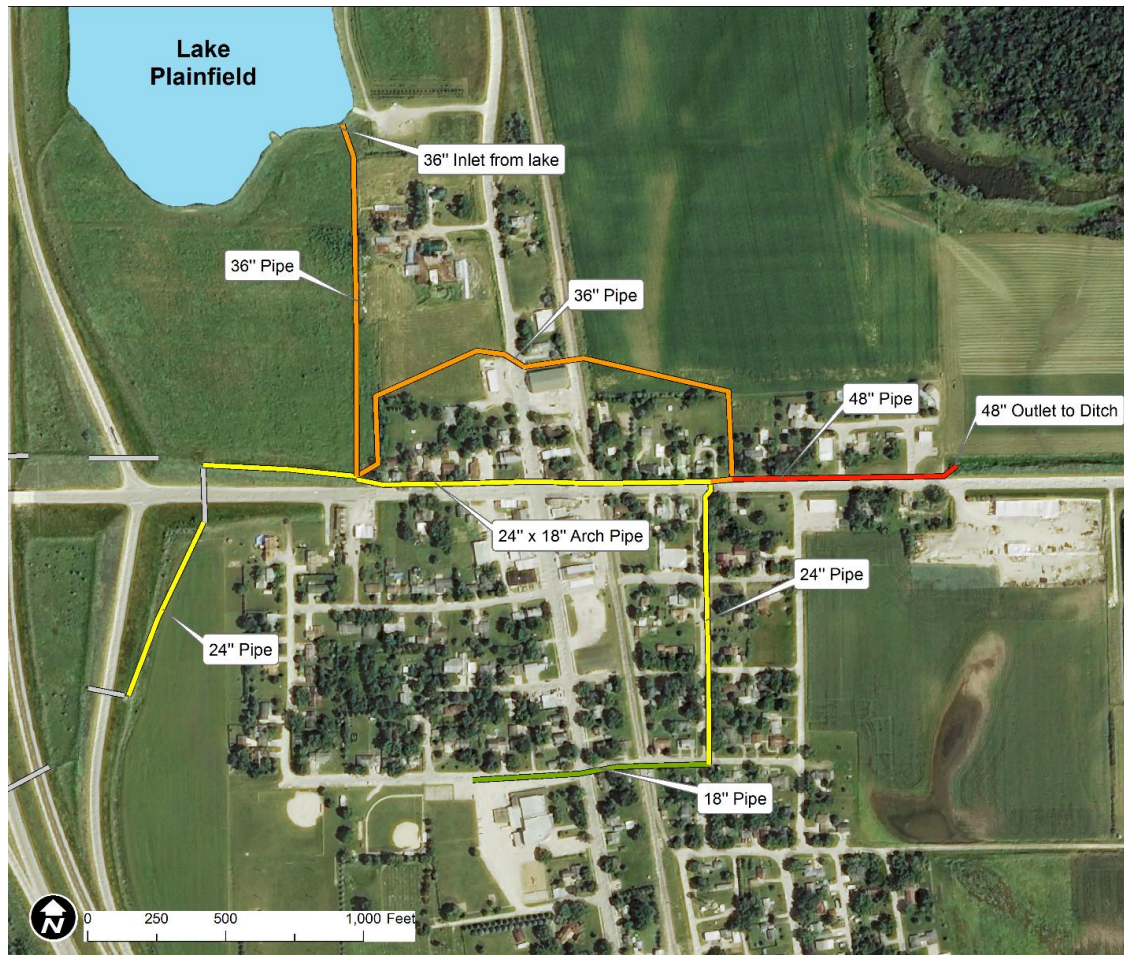
Figure 2.8. Storm sewer mains, colored by pipe size.

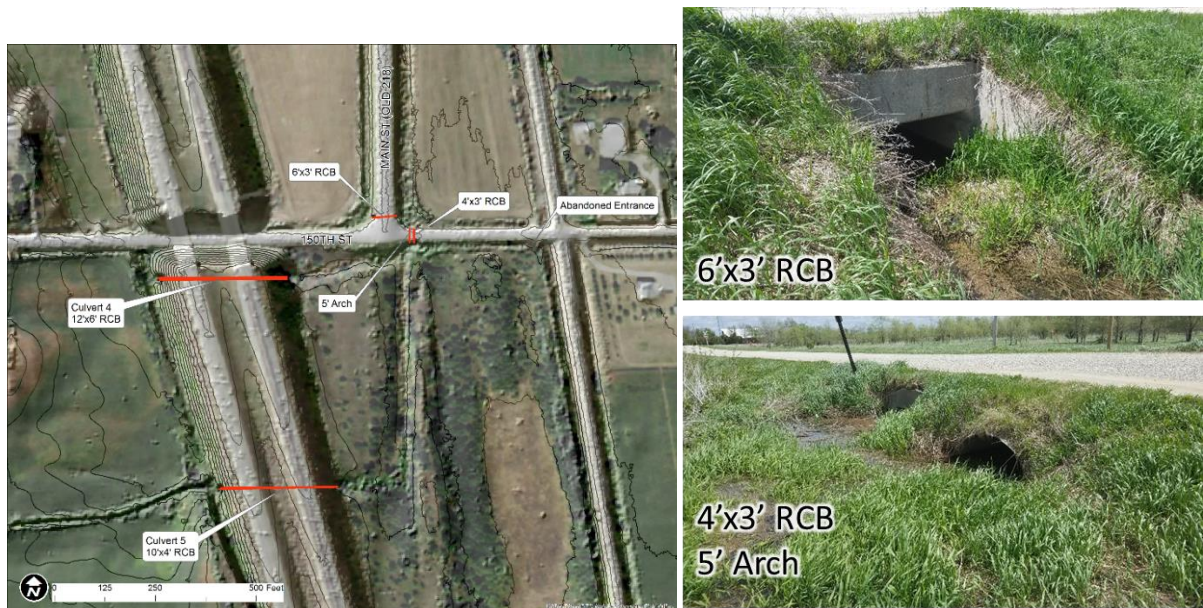
Figure 2.10. The other outlet is through culverts near the intersection of Main and 150th Streets, prior to entering the Iowa DOT wetland Mitigation Area. Photographs provided by Andy Luck.

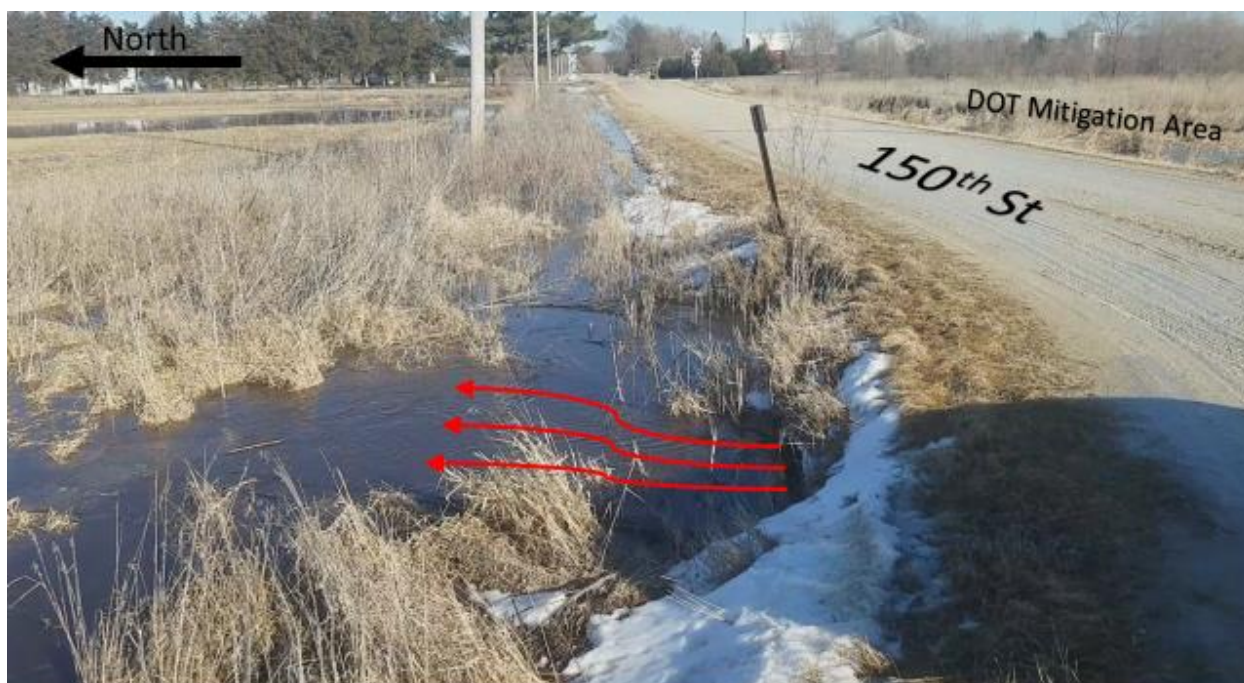
Figure 2.11. Runoff flowing north from Iowa DOT Wetland Mitigation Area by traveling under 150th St. Video captured by Andy Luck following a snow melt.

Once water ponds to a sufficient level near the intersection of Main and 150th streets, water will continue flowing through the wetland mitigation area, reaching a railroad trestle bridge located at the southeast corner of the wetland mitigation area, shown in Figure 2.12. It is possible that high ground on Canadian National Railway or the privately-owned property just to the east of the trestle bridge opening may be an impediment to flow. A defined outlet at this location would allow flood waters to continue flowing through the mitigation area.

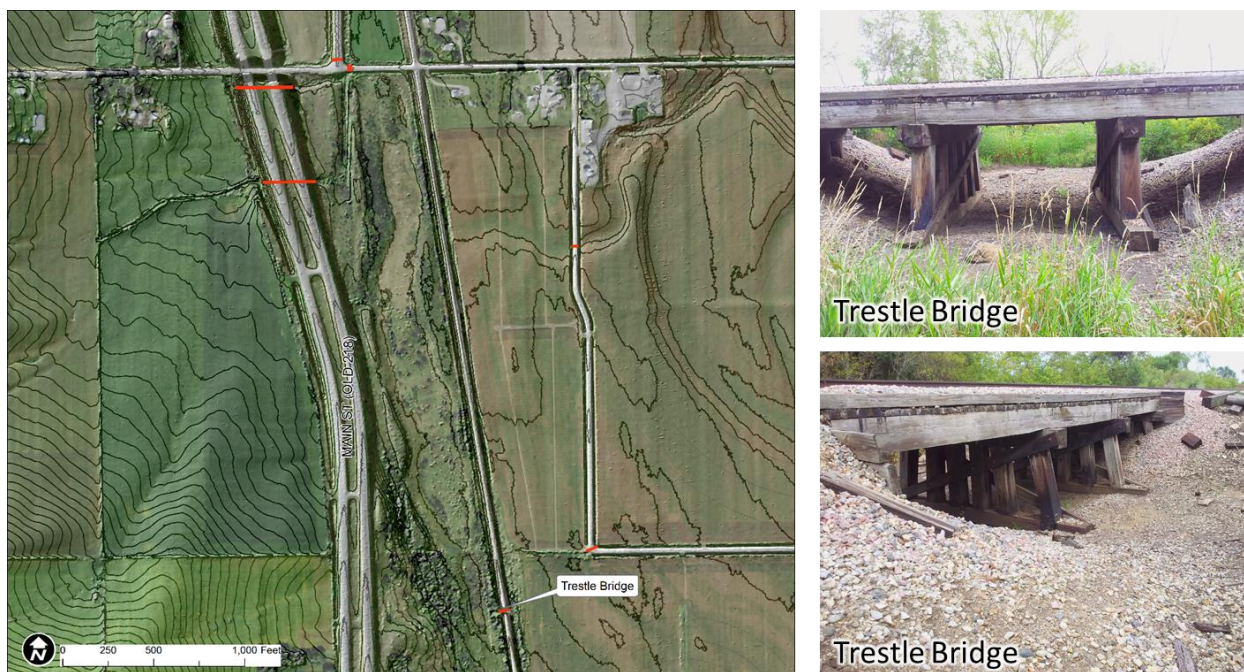
Figure 2.12. Location of the trestle bridge, the only outlet for the Iowa DOT Wetland Mitigation Area. Photographs provided by Andy Luck.

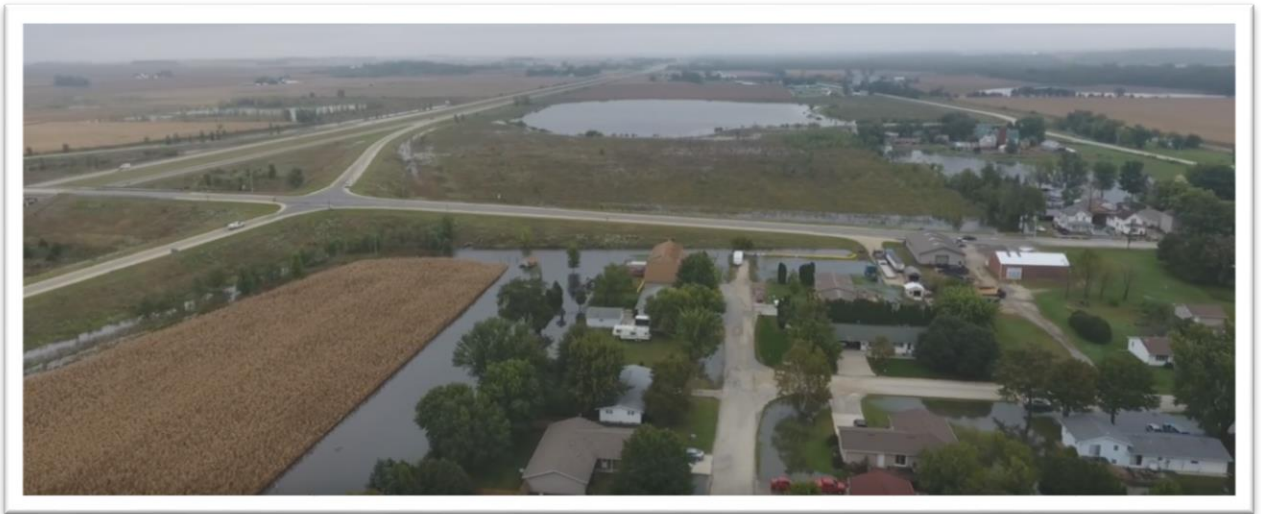
Figure 3.4. Drone footage captured at 5:00pm September 23, 2016 by Kip Ladage, Bremer County Emergency Management Coordinator. View is looking north towards Lake Plainfield.

The series of rainfall events generated large quantities of runoff in the nearby agricultural catchments, and eventually caused severe flooding in Plainfield. Surface flooding was documented by Kip Ladage, Bremer County Emergency Management Coordinator, in several drone videos captured September 23rd and 24th, 2016. Runoff from catchments 6 – 9, west of US-218 and north of IA-188, flowed into Lake Plainfield, exhausted lake storage and overwhelmed the 36 inch storm sewer outlet. Surface water then flowed overland in a southerly direction, passing under IA-188 through a culvert and inundating several homes near West Street. In addition to surface flooding, many homes also incurred damages from ground water resulting in basement flooding. A view looking north towards Lake Plainfield during the 2016 event is shown in Figure 3.4.

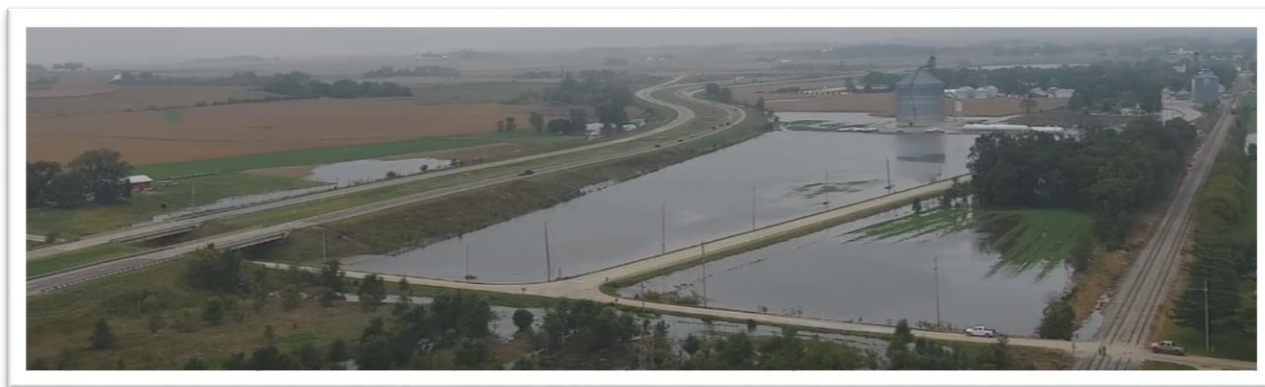
Figure 3.6. Drone footage captured at 5:00pm September 23, 2016 by Kip Ladage, Bremer County Emergency Management Coordinator. View is looking north near the intersection of Main and 150th streets, south of Plainfield.

Large quantities of runoff were generated in catchments 1 – 5 that eventually flowed under US-218 through several culverts, combining with Lake Plainfield overflow in the areas between US-218 and the west side of Plainfield, which can be seen in Figure 3.5. The main outlets for the flood water is traveling through Main St., 150th St. the railroad, and eventually, the Iowa DOT wetland mitigation area, shown in the bottom of Figure 3.6.

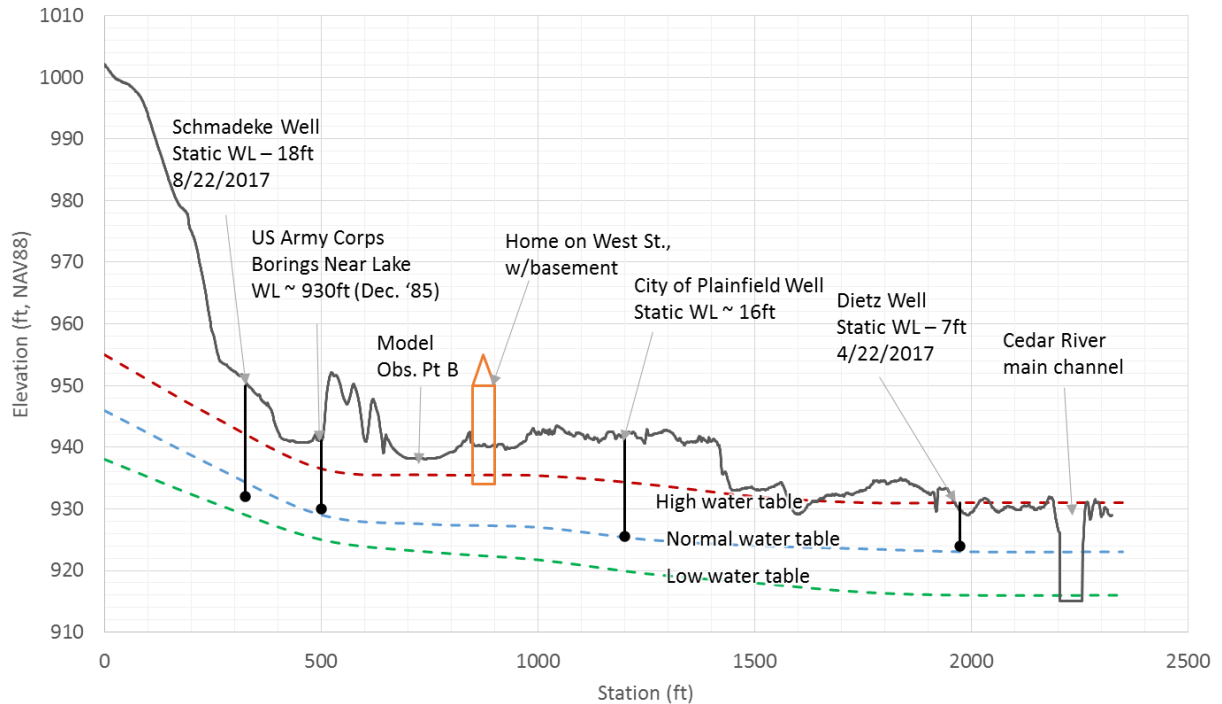
Figure 4.2. Plot of an east-west cross-section through Plainfield. Several historical measurements of depth to static water levels were plotted together with hypothetical high-, low, and normal water table profiles.

proximity to any ponded surface water, and many other factors. Given the presence of underlying impervious soil layers found in exploratory soil borings collected by USACE, and the conclusions of the 1987 Section 205 study, it is possible nearby standing water could be contributing to the high groundwater levels affecting the community.

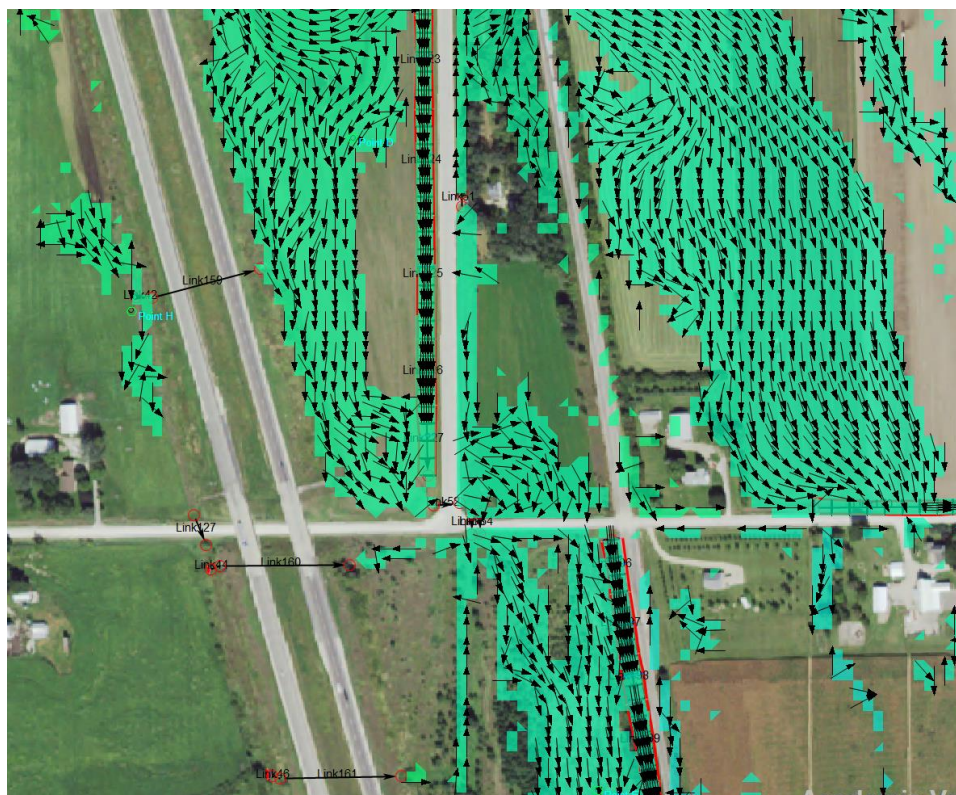
Figure 5.1. The XPSWMM model is capable of simulating rainfall-runoff, infiltration and flood through drainage system using a combination of 1D structure elements connected to a 2D grid of the terrain.

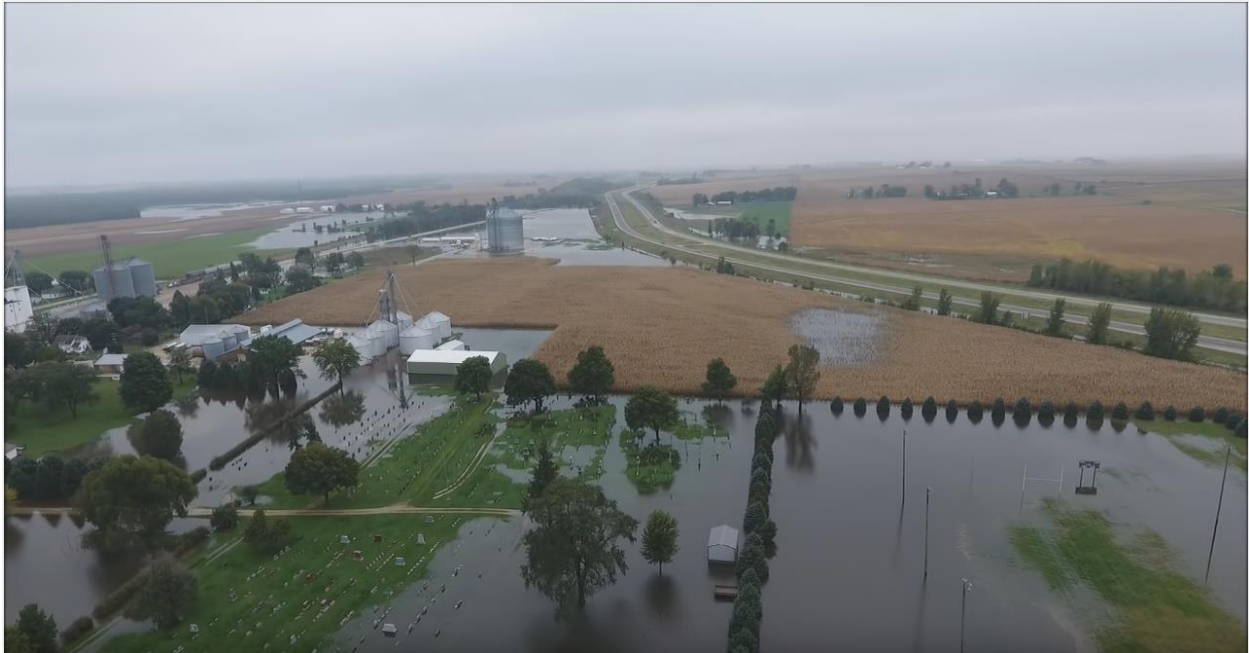
Figure 6.1. Comparison of observed inundation during the September 2016 flood event (top) and XPSWMM simulated flood extent (bottom) displayed in Google Earth.

The best available data for model validation are the Flood of September 2016 drone videos captured by Kip Ladage, Bremer County Emergency Management Coordinator. Qualitative comparisons of the simulated and observed flood extents were made from several viewpoints corresponding to the time of captured drone footage. An example comparison of the area between Plainfield and US-218 is shown in Figure 6.1. An example comparison of the area south of the Landus Coop and north of the Iowa DOT Wetland Mitigation Area is shown in Figure 6.2. The simulations appear to match the flooding extent in the drone videos closely.

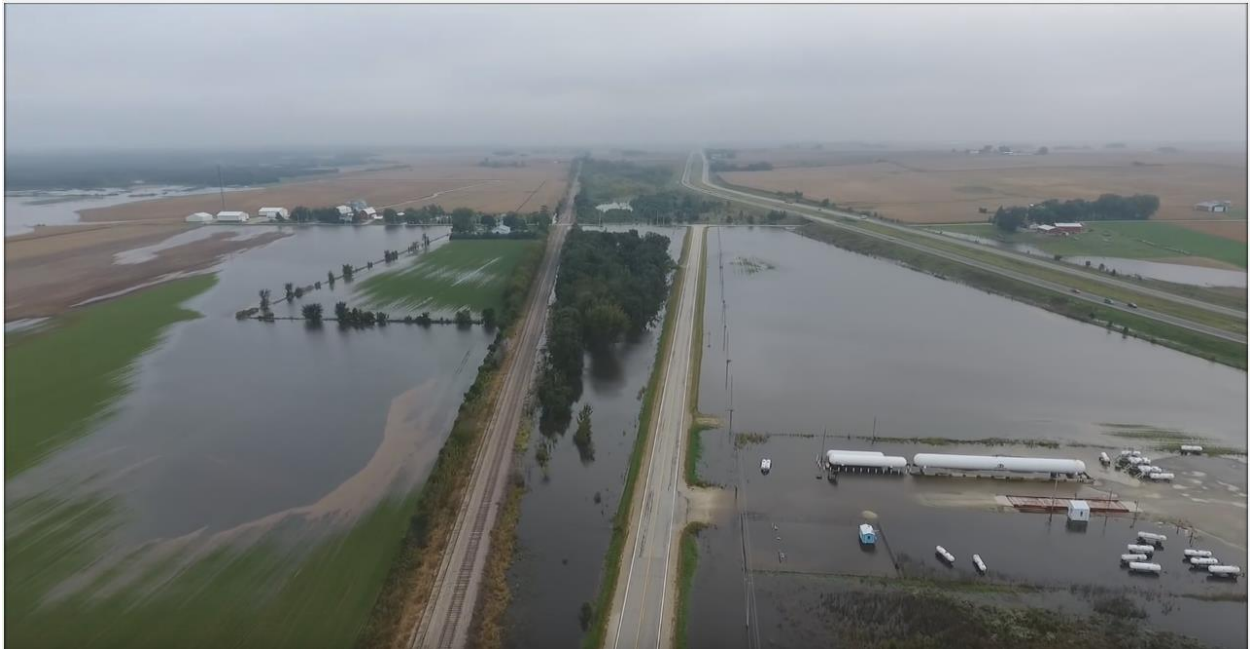
Figure 6.2. Comparison of observed inundation during the September 2016 flood event (top) and XPSWMM simulated flood extent (bottom) displayed in Google Earth.

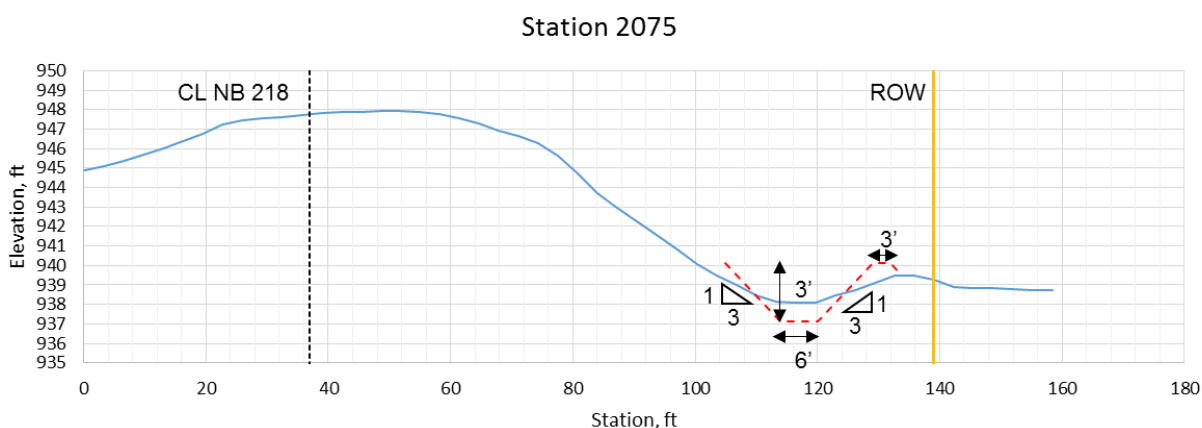
Figure 7.12. East Ditch, in ROW, typical cross-section at station 2075 ft.

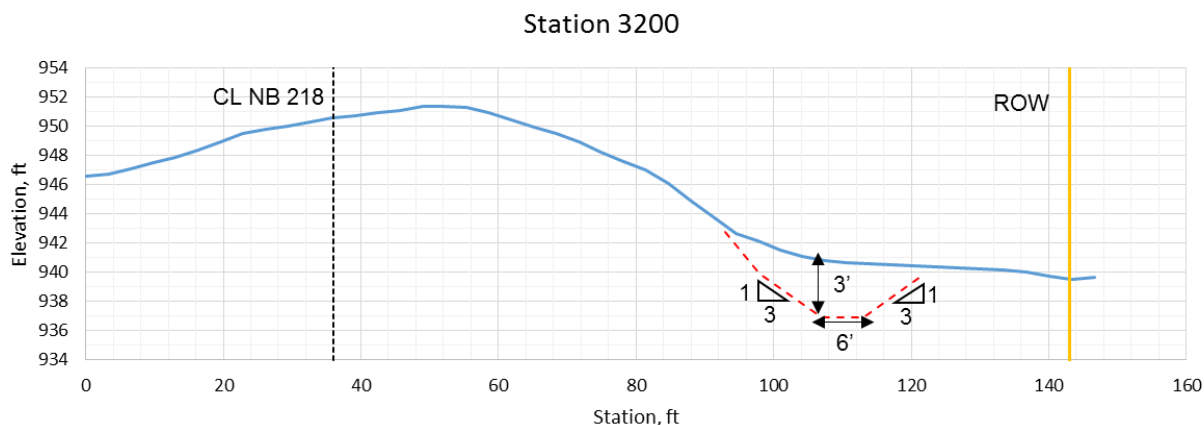
Figure 7.13. East Ditch, in ROW, typical cross-section at station 3200 ft.
